CHAPTER 1 - PURPOSE AND NEED

1.1 INTRODUCTION

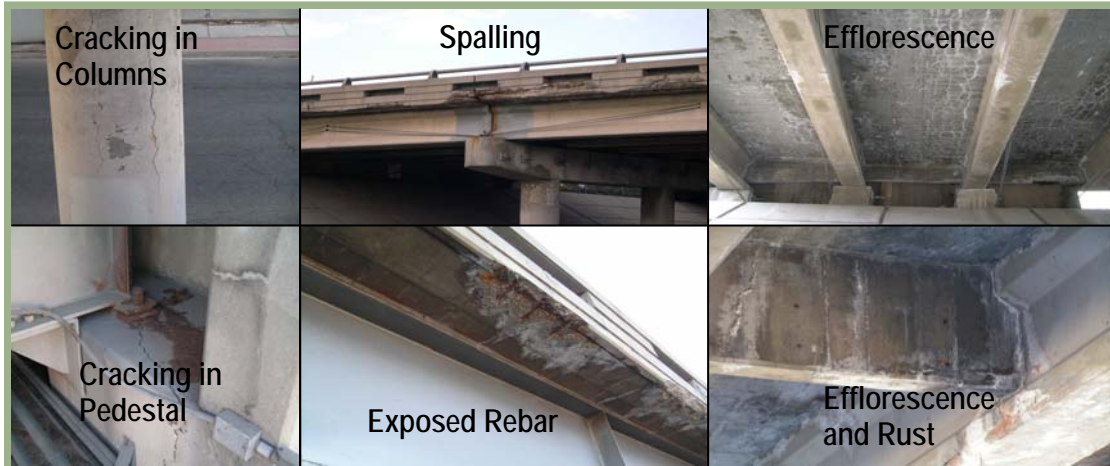
Figure 1-4. Examples of the Types of Deterioration of the I-80 Bridge Structures

the girders⁸. The majority of the bridges show cracking in the abutment backwalls and/or the pedestals that support the girders and, in some areas, the slope protection underneath the bridges is displaced. See Table 1-1 – Summary of Existing I-80 Bridge Structure Deficiencies below for specifics as to deficiencies identified for each structure. Some examples of the deterioration identified in the project area are illustrated in Figure 1-4.

Since all of the bridges were originally built within a relatively short time of each other⁴, they exhibit similar evidence of deterioration and damages, such as cracking, delamination,⁵ efflorescence,⁶ spalling,⁷ and the exposure of steel rebars in both the bridge decks and the substructures. Water leakage through the expansion joints has impaired the integrity of the exterior girder bearing seats and there is rust on several of

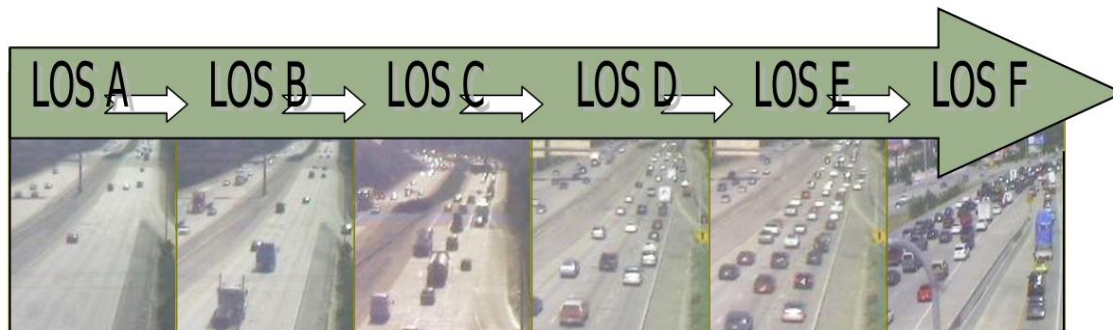
Figure 1-5. Level of Service

Level of service (LOS) is a concept used to describe the operation of a roadway. Levels of service characterize traffic operations in terms of speed, average travel delay, travel times, freedom to maneuver, and driver comfort and convenience and range from a rating of “A” to “F”, with A representing the most optimal operating conditions and F representing the worst operating conditions. In urban areas, such as the project area, a LOS D is acceptable for planning. Figure 1-6 is an approximate visual representation of LOS categories showing I-80 traffic conditions.
